HERON ROAD BRIDGE (A)

On August 10, 1966 one of the spans of the Heron Road Bridge in Ottawa collapsed during pouring of the deck, carrying nine persons to their deaths and causing injury to many others. This case presents the story of the collapse and the subsequent investigation as recorded in the press and trade journals. This case focuses on engineering aspects of the tragedy and many human interest aspects have had to be omitted. It is hoped that the lessons to be drawn from this case will help prevent future tragedies of this kind.

Report on the Heron Road Bridge Failure

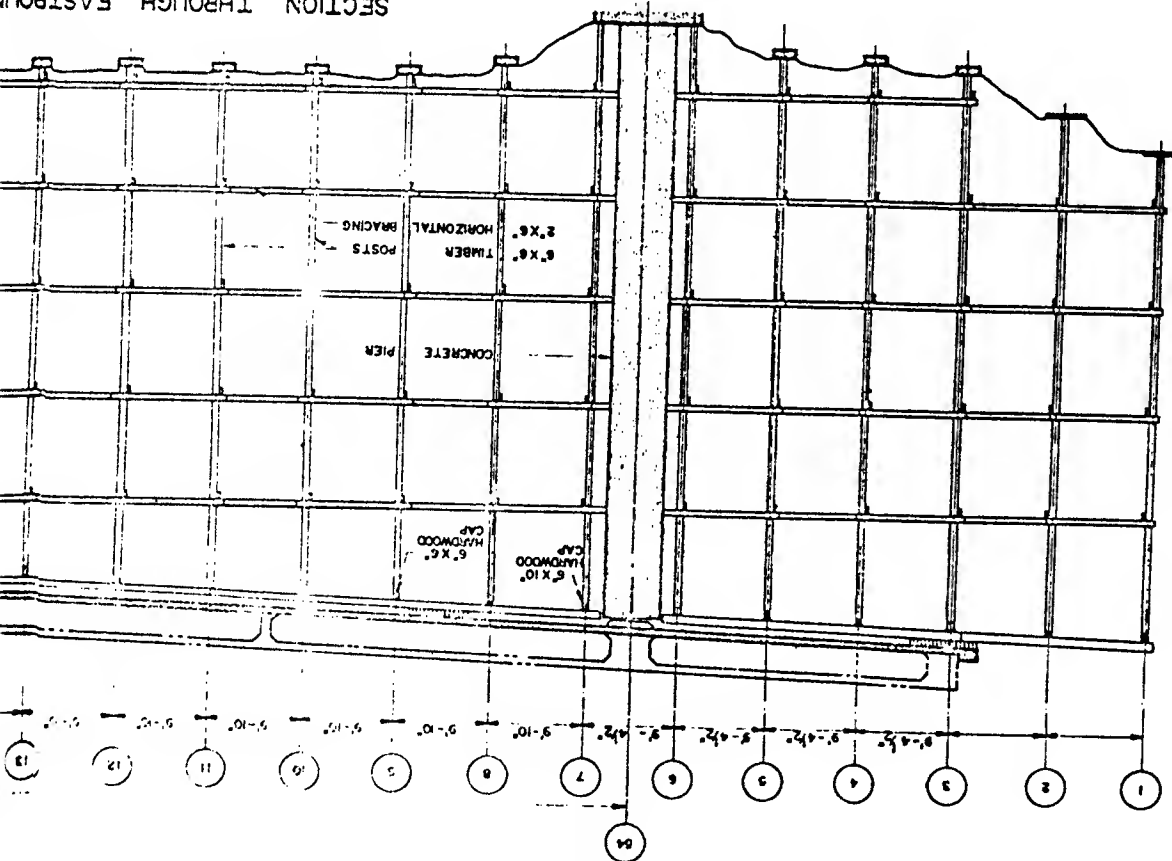
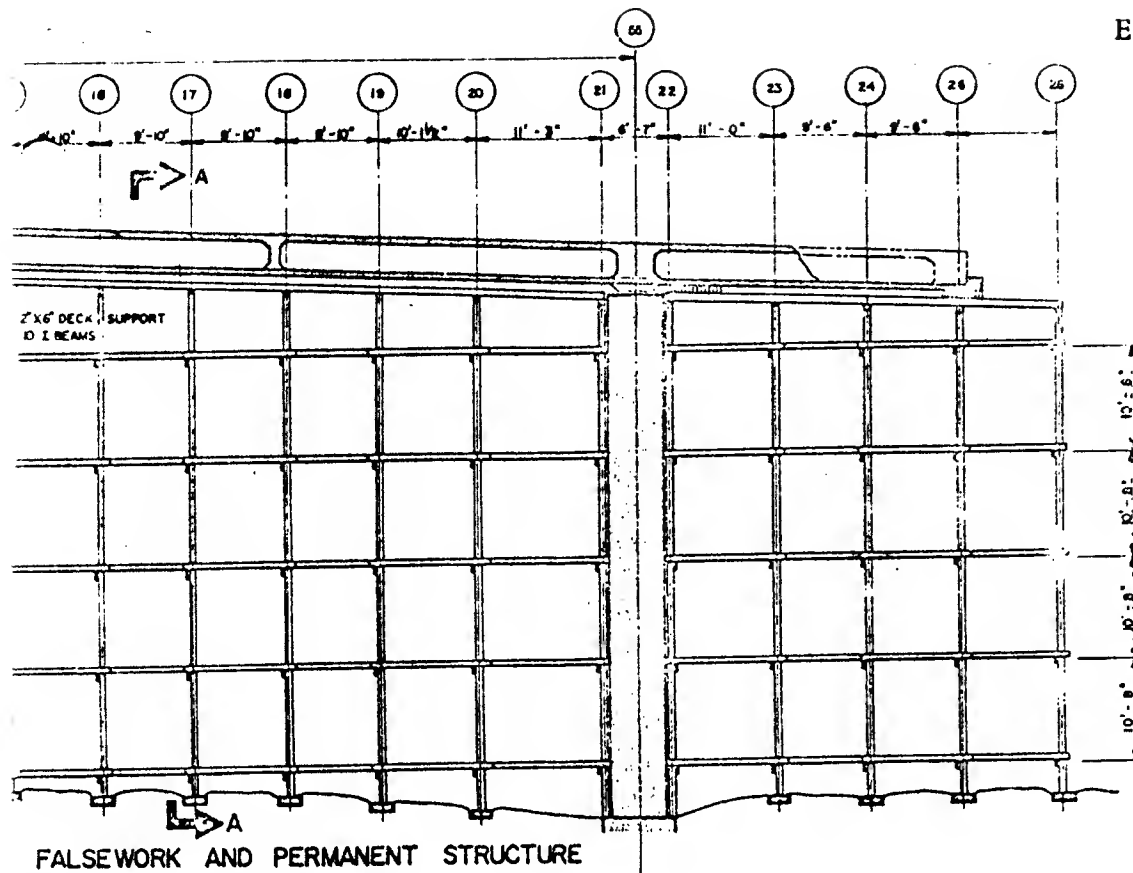
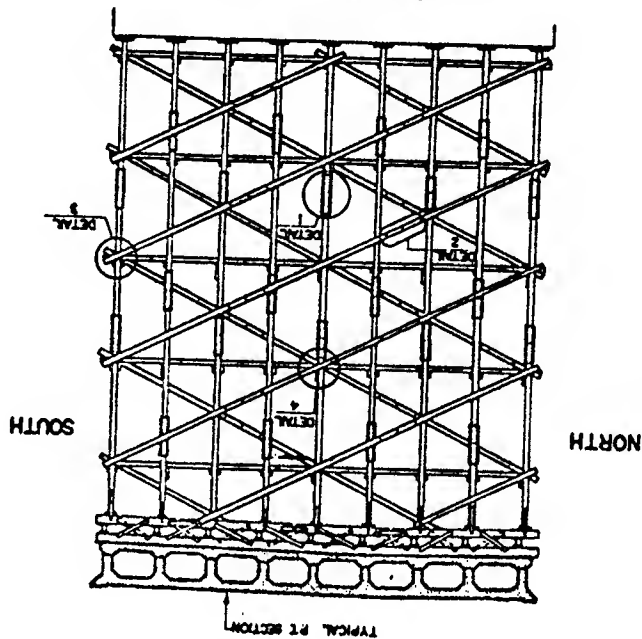
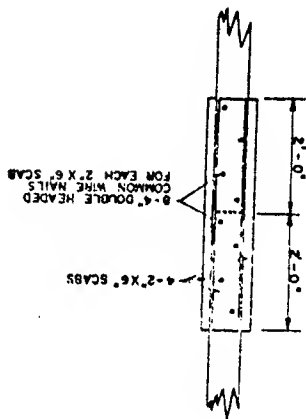
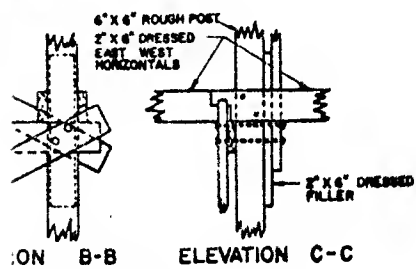
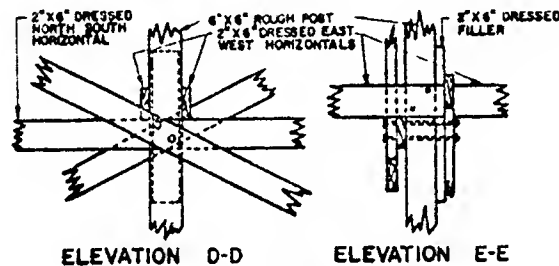
Exhibit B-3

- 2.13 The act of removing the longitudinal, diagonal bracing from the construction drawings for the falsework for span PT3S, O. J. Gaffney Limited drawings Nos. G-1886-14 and 16, which led to the preparation of the revised drawings Nos. G1886-14A and 16A, indirectly caused the collapse of the structure.

The basic concept of the design appears to have been a reliance on the permanent piers to provide supports for the falsework structure in the longitudinal direction. This concept was fallacious since only 1/3 of the posts were braced against the piers, while the remainder were hindered from deforming longitudinally only by the rather low flexural rigidity of the transverse bents, which in ordinary engineering design is not taken into account at all.

As a consequence, the buckling lengths of the posts of the outer six lines was the full height of the falsework structure and not the 10-foot 8-inch panel height assumed in the original design of the falsework. Under this condition, the posts were completely inadequate to support the loads applied to the structure at the time of collapse.

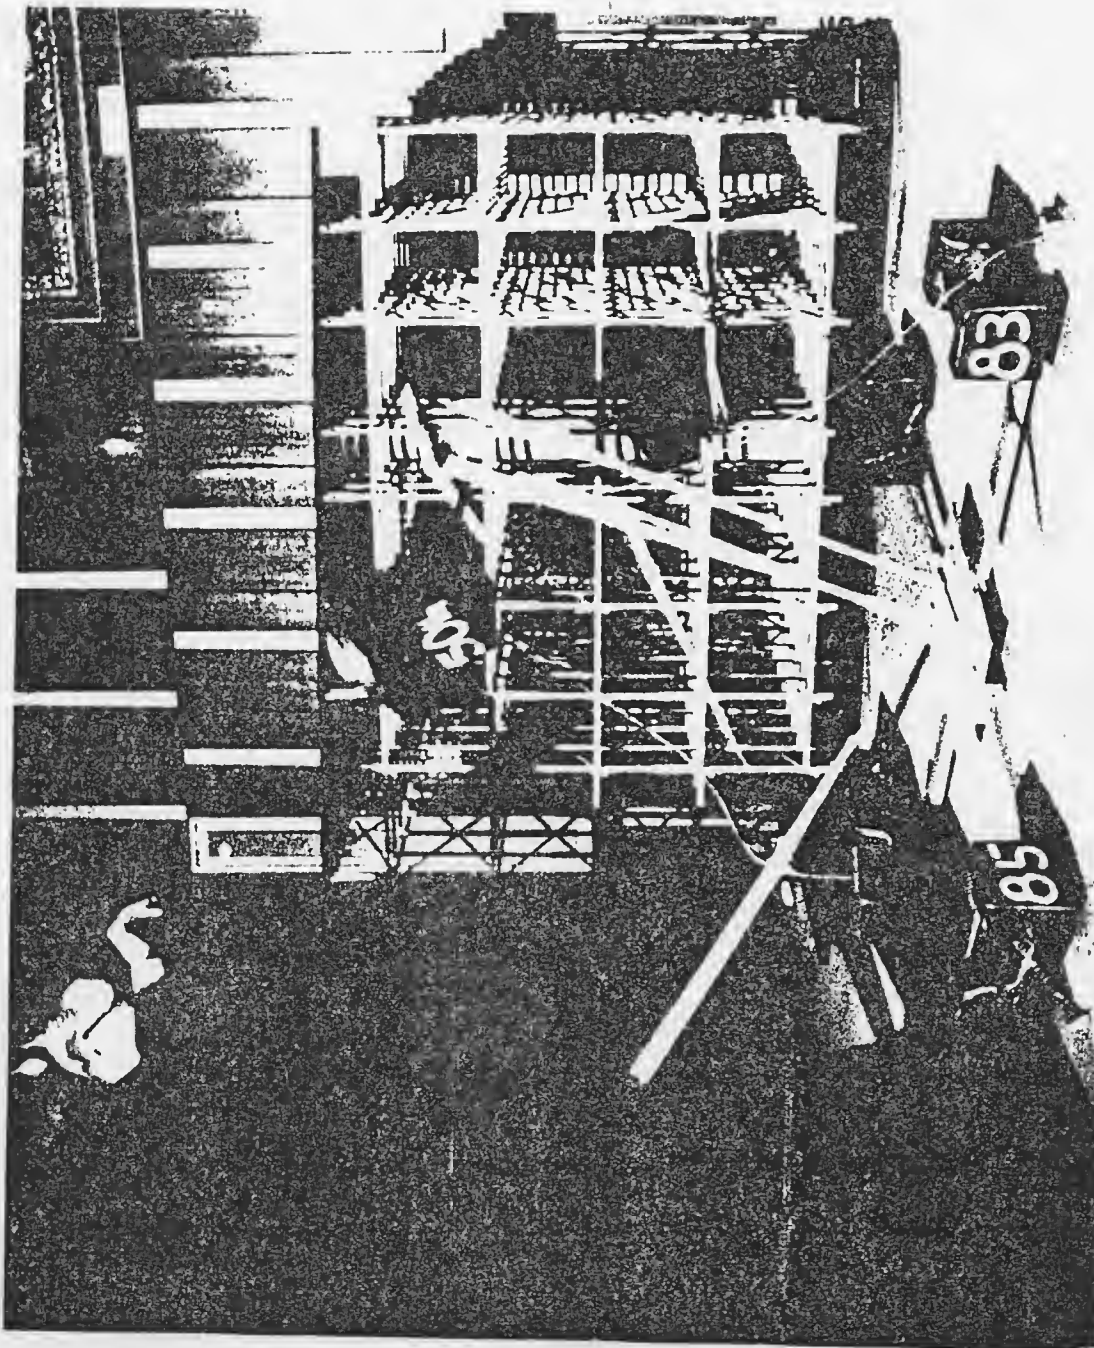
Exhibit C-1. Professor C. F. Morrison, University of Toronto, demonstrating before the Coroner's Inquest how inadequate bracing of falsework caused the collapse. (From U.P.I.)
